## Field Report

**Project:** Shepherd of The Hills Lutheran Church

**Report #:** 1

**Date:** 6-25-19

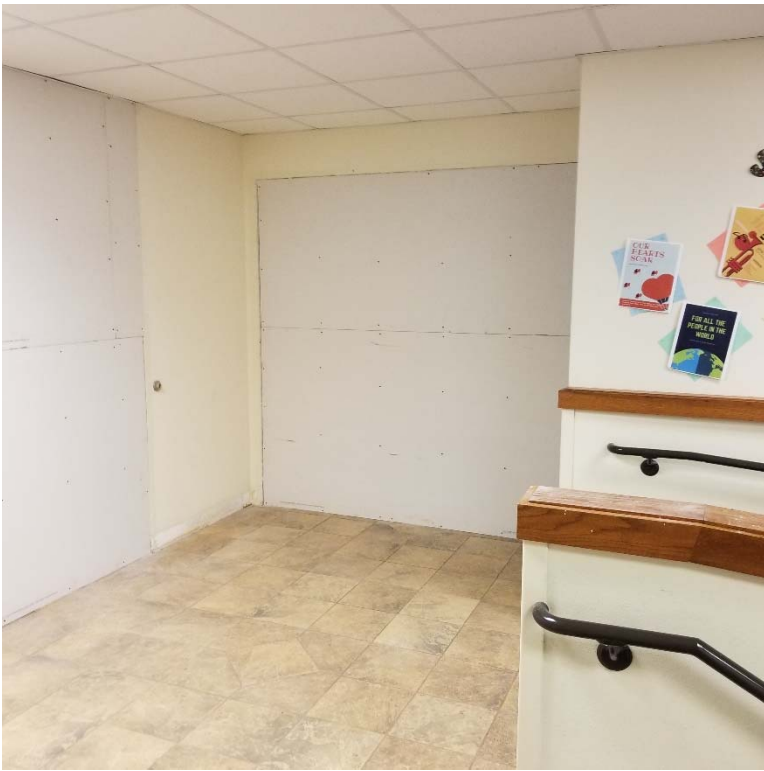
Door openings at top of ramp have been studded shut and gyp bd has been installed. While this make a great temporary wall, the exit door to the east must be maintained throughout construction as a means of egress. This info was communicated to Larry from Calmes.

**Image #1: Existing door opening at top of ramp has been studded shut.**

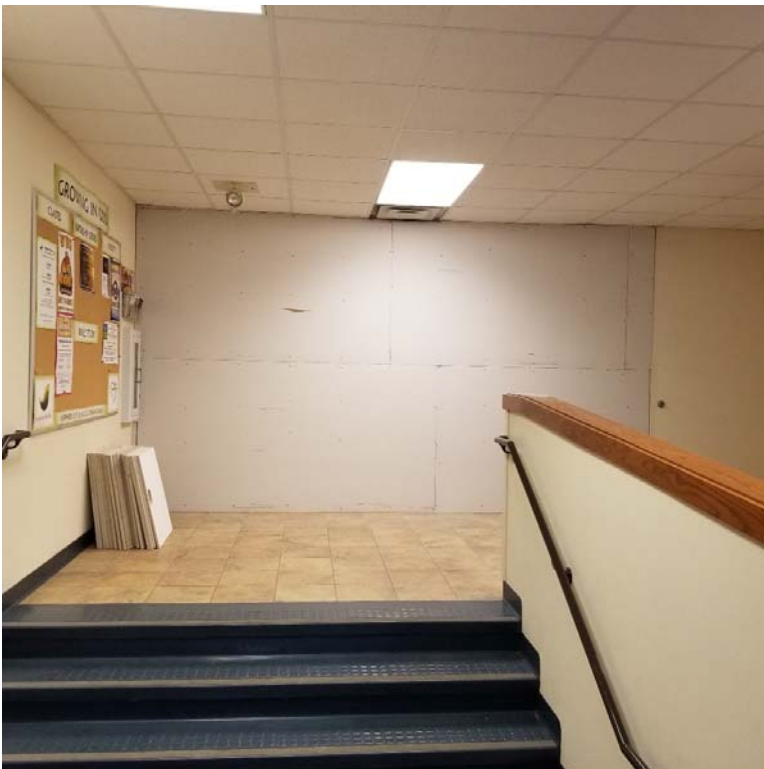
**Image #2: Existing door opening at top of ramp has been studded shut. This needs to be opened up and a tempdoor must be installed for egress throughout the duration of construction.**

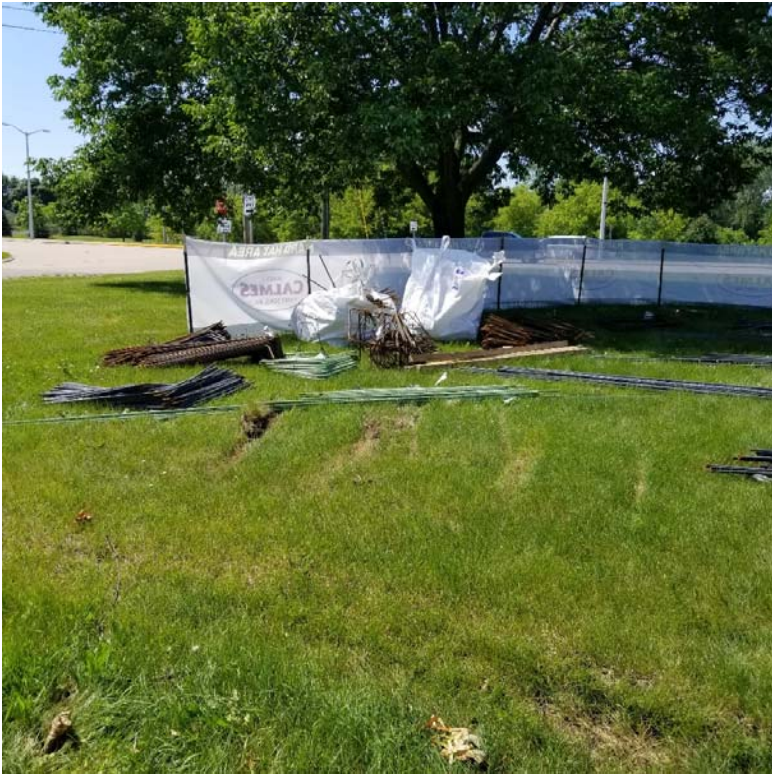
Re-bar for new concrete work is being stored on site- this should be re-positioned up & off of the ground to avoid rusting prior to install
-

**Image #3: Re-bar is being stored on south end of site. This should be on wood blocking above grade to avoid rusting**

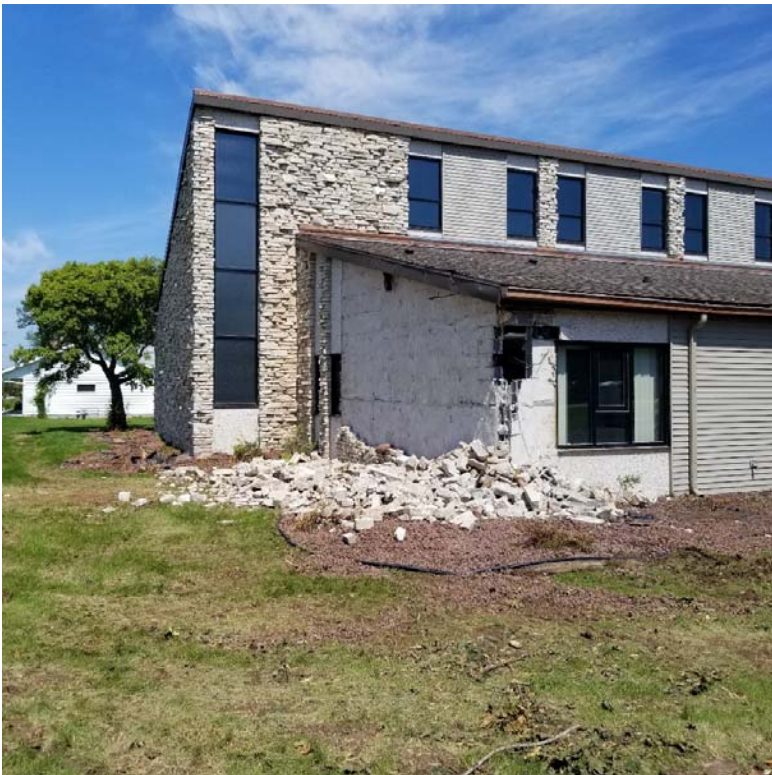
**Image #4: Southeast corner of the church. Stone has been peeled off and will be stored on-site for congregation members to use.**

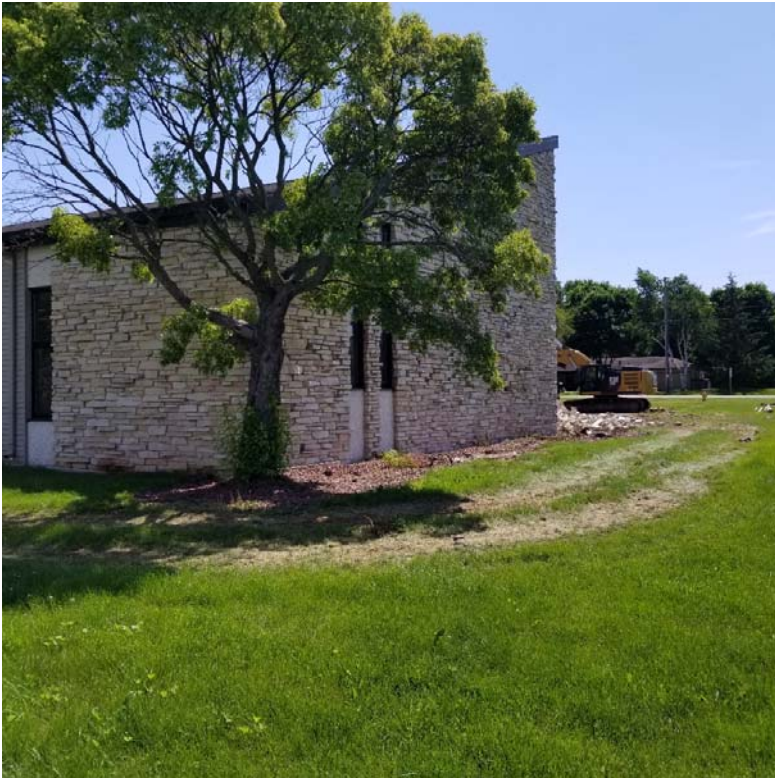
**Image #5: South wall of the sanctuary viewed from the southwest.**

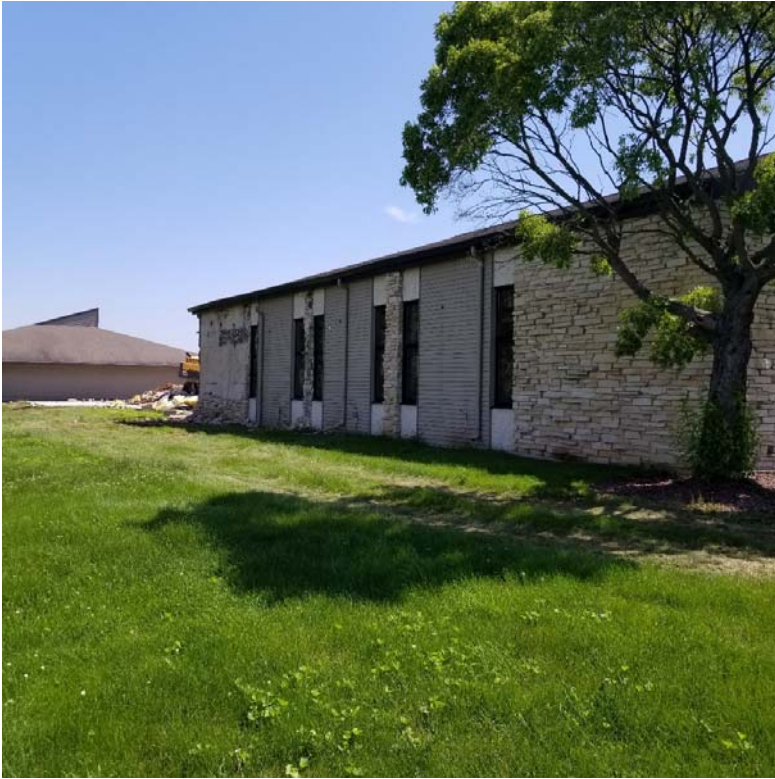
**Image #6: West wall of the sanctuary**

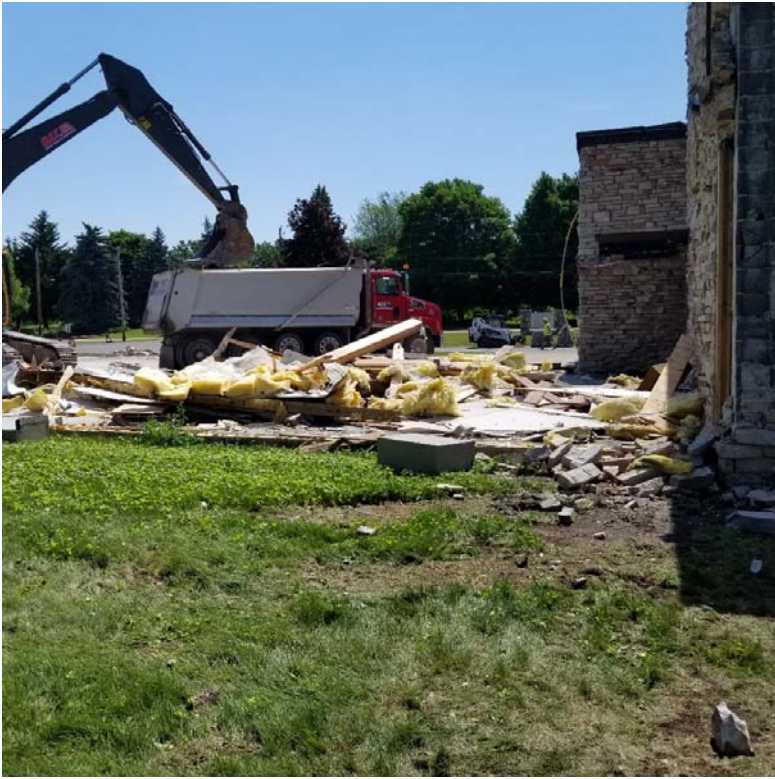
**Image #7: This used to be the narthex!**

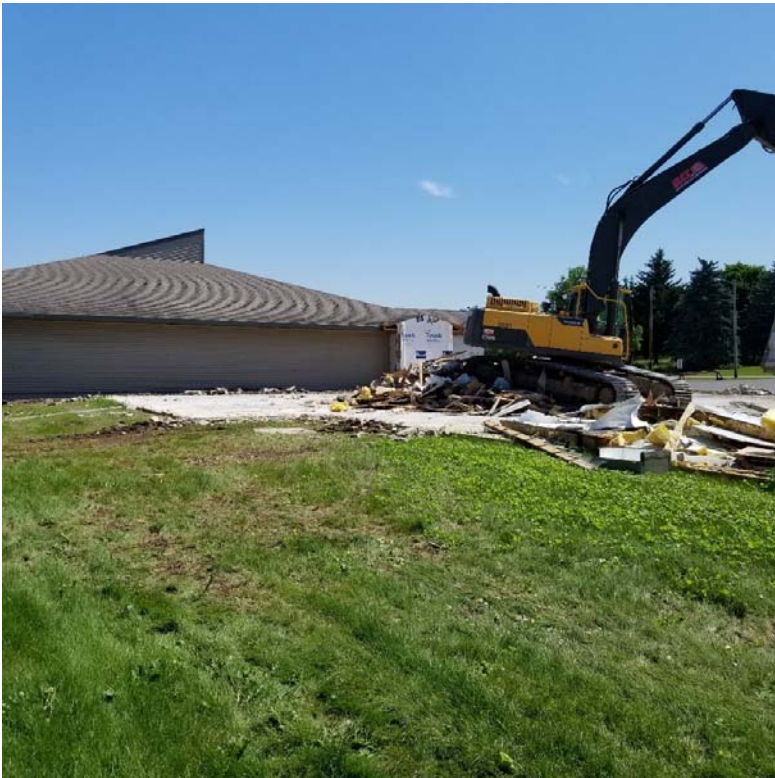
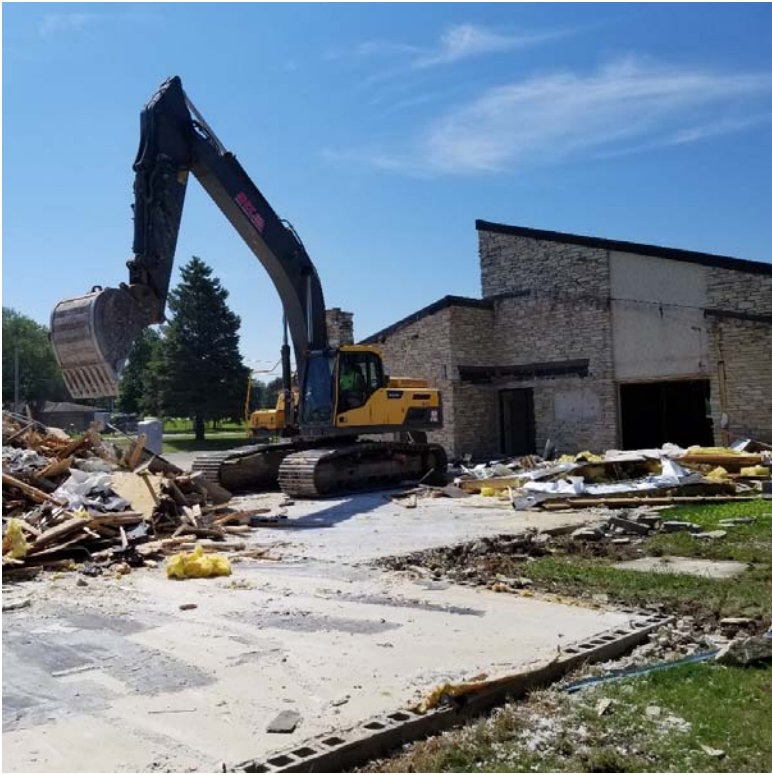
Demolition is well underway. The fellowship hall and connecting link to classroom wing have been removed. The last couple of truckloads of debris are being removed prior to the start of demo of the sanctuary.
-

**Image #8: Excavator is sitting in the old fellowship hall. Removal of the last couple of loads of debris from that area is in progress**

**Image #9: Excavator is sitting in the old fellowship hall. Removal of the last couple of loads of debris from that area is in progress**

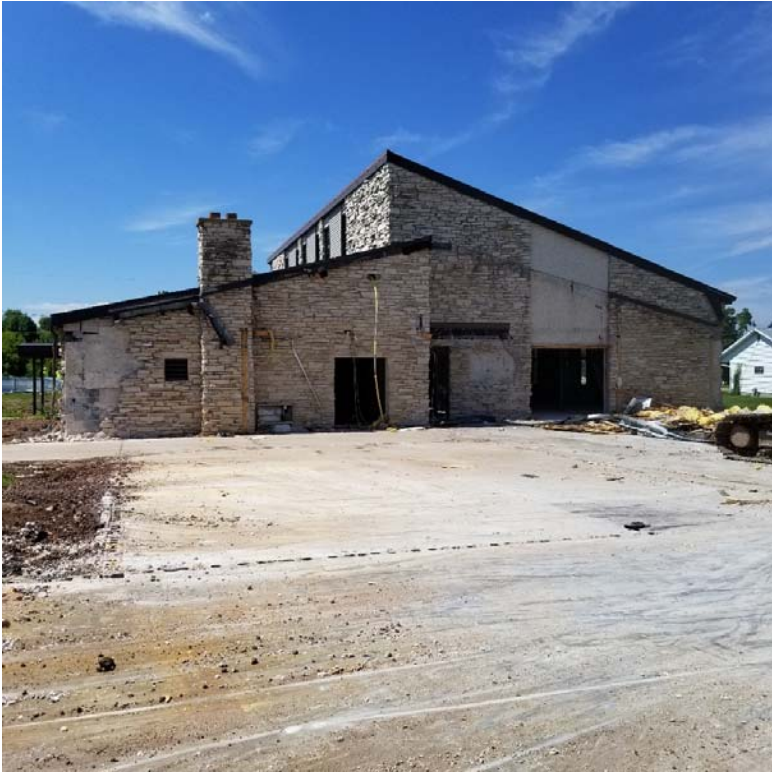
**Image #10: Standing in the old fellowship hall looking at the north wall of the church**

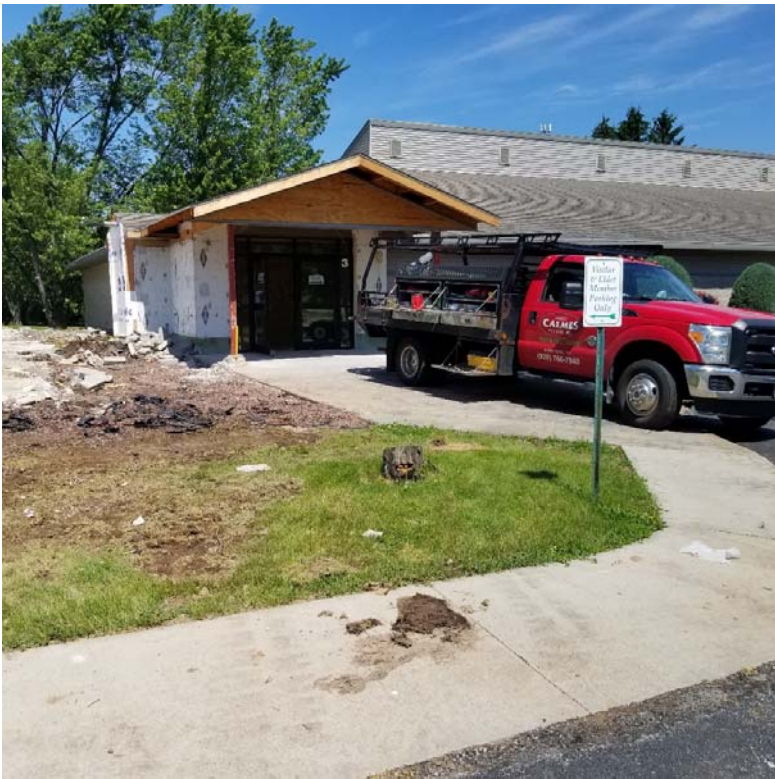
**Image #11: Demolition of the existing entry to the church offices has begun.**

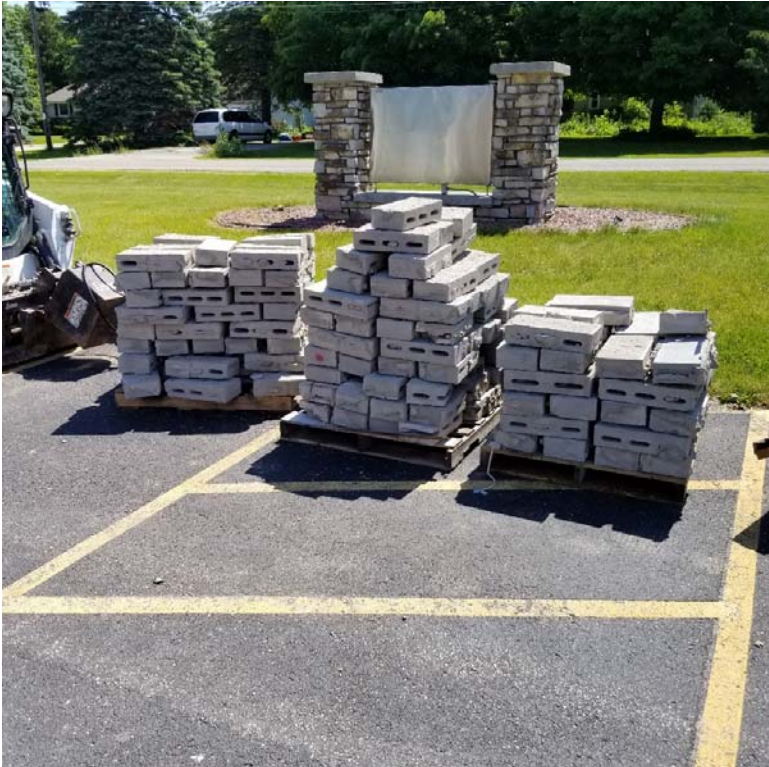
**Image #12: Existing split face masonry has been salvaged and stored (per drawings) so that it can be reused as infill at new connecting corridor**
