## Field Report

**Project:** Shepherd of The Hills Lutheran Church

**Report #:** 2

**Date:** 6-27-19

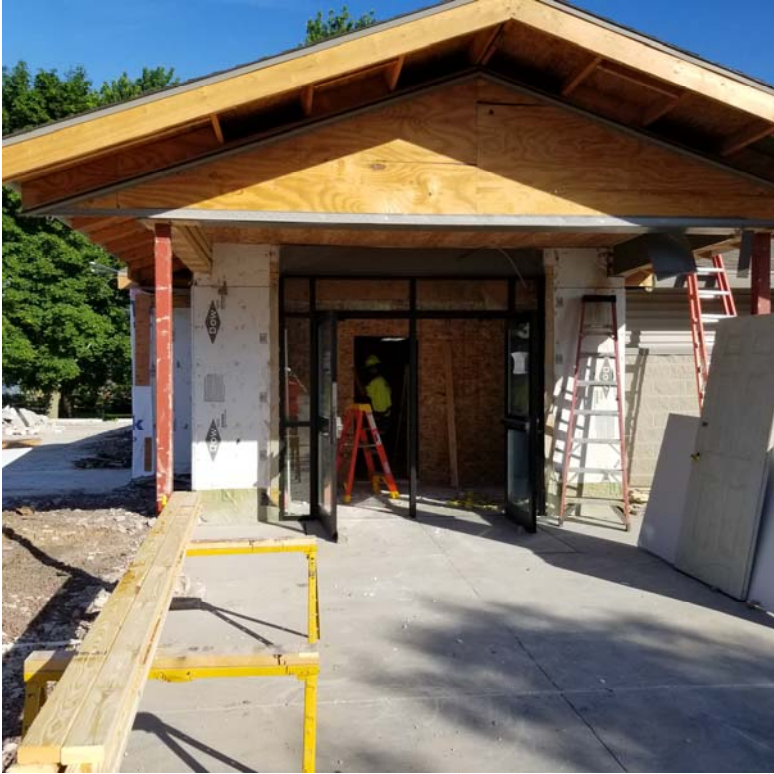
**Image #1: New (temporary) egress door is being cut/framed into the east wall at the top of the ramp.**

Cutting temporary egress door into the east wall at the top of the stairs.

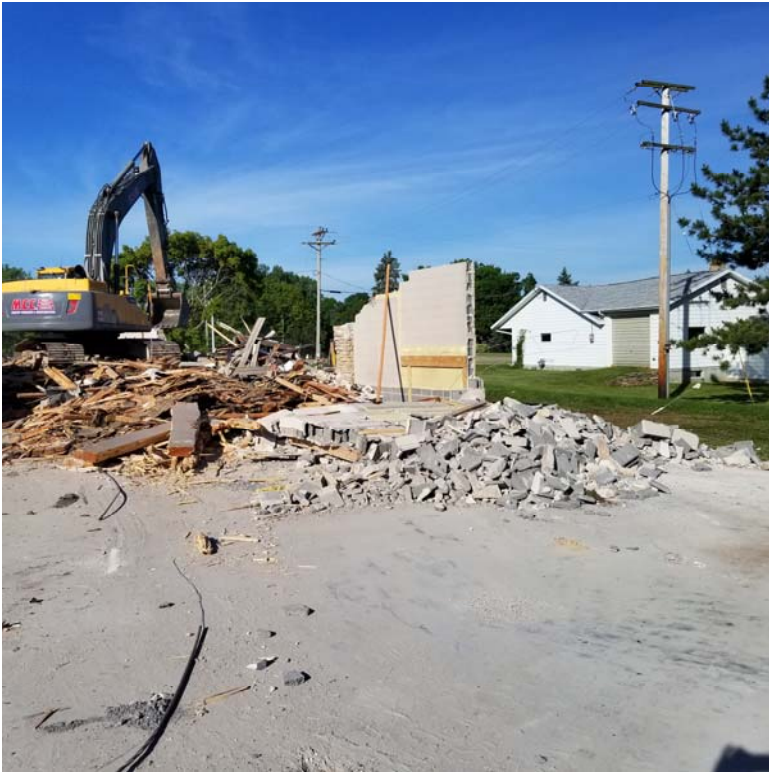
**Image #3: Only a small portion of wall (this was the west wall of the mezzanine stairwell) remains on the west side**

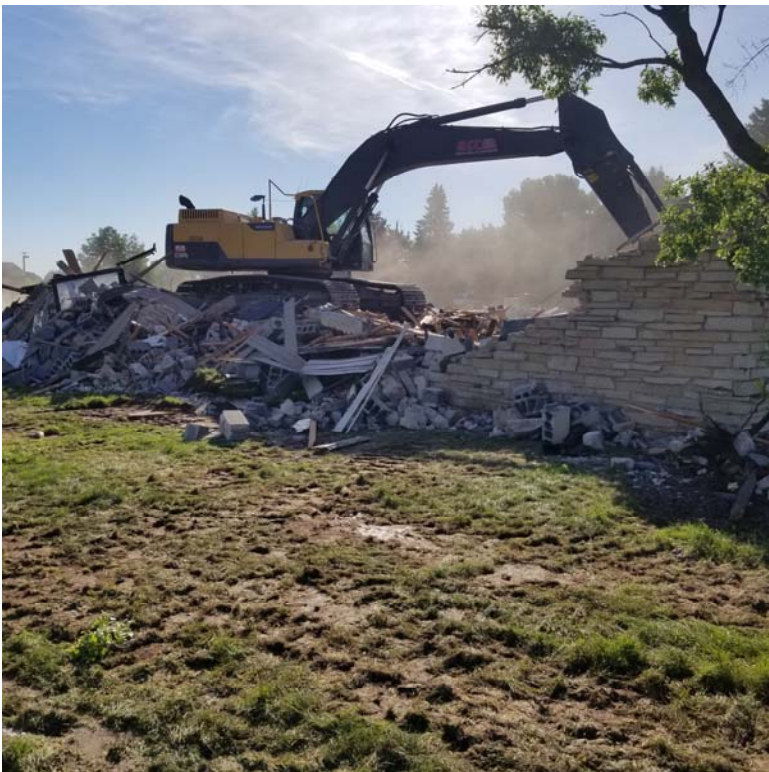
**Image #4: Debris being removed at the southwest corner of the church..**

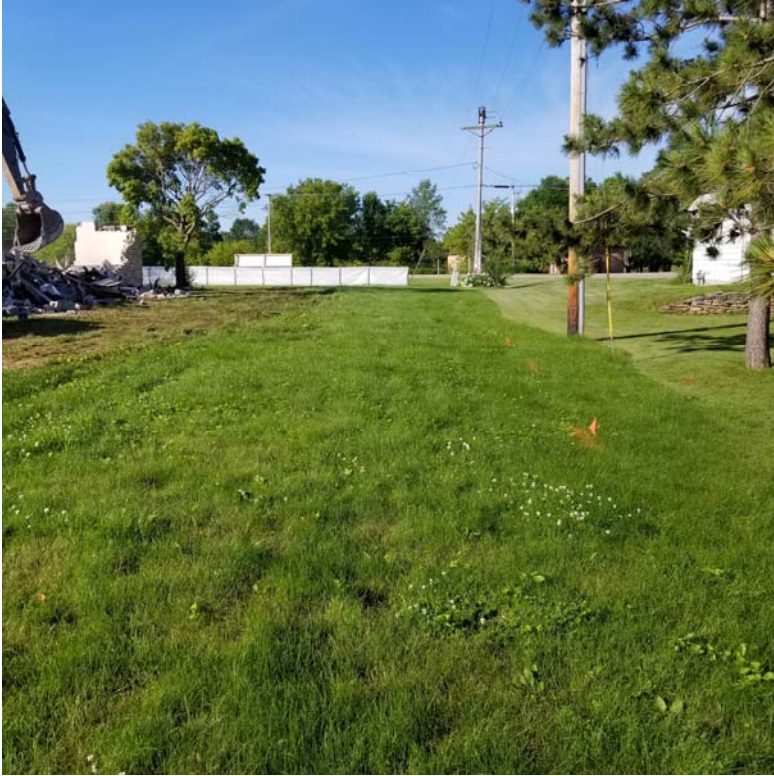
**Image #5: West side of the site is being kept clean.**

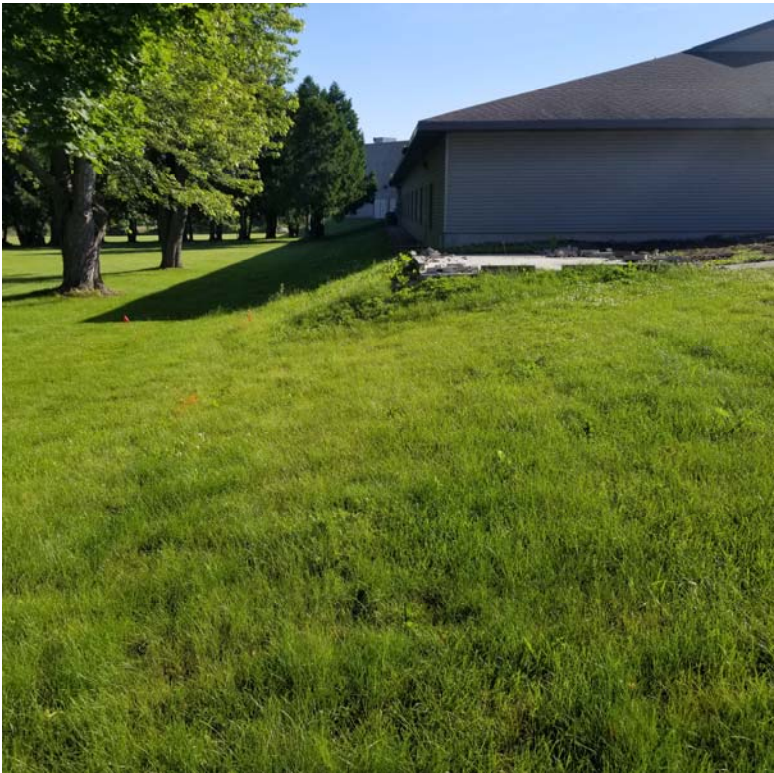
**Image #6: West side of the site is being kept clean**

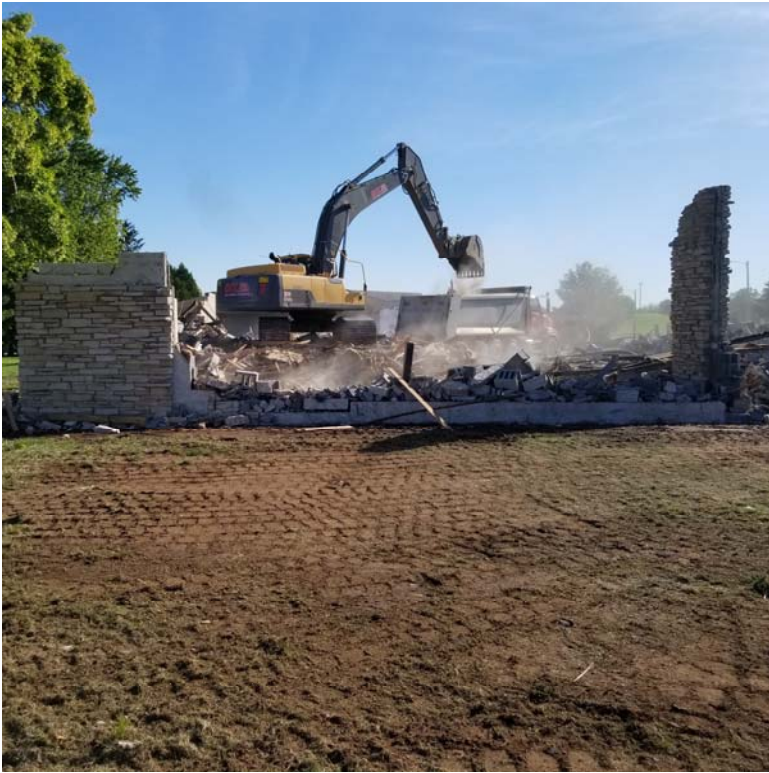
**Image #7: Only the south corners of the church remain in place.**

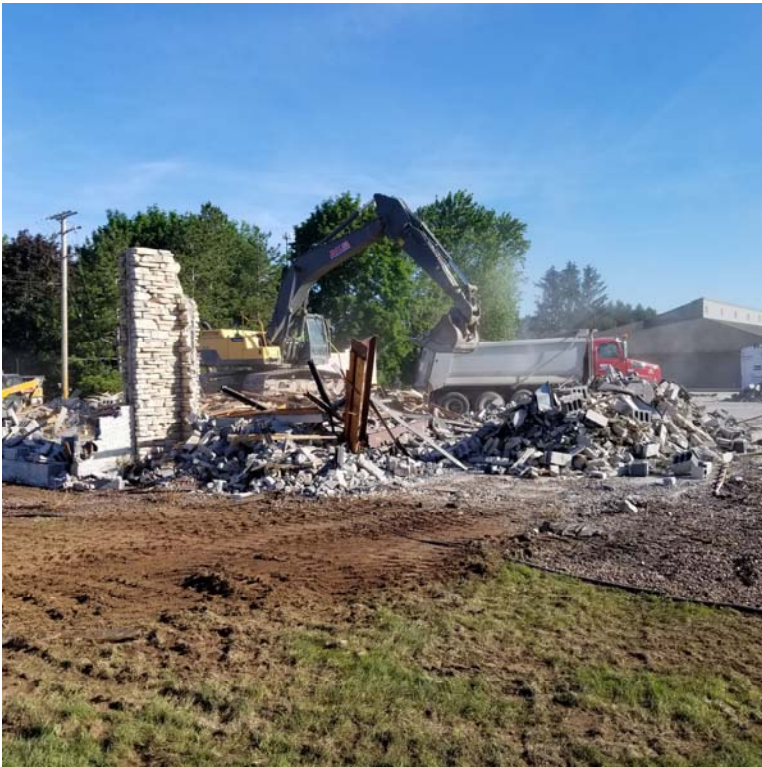
**Image #8: Debris removal- looking from the southeast.**

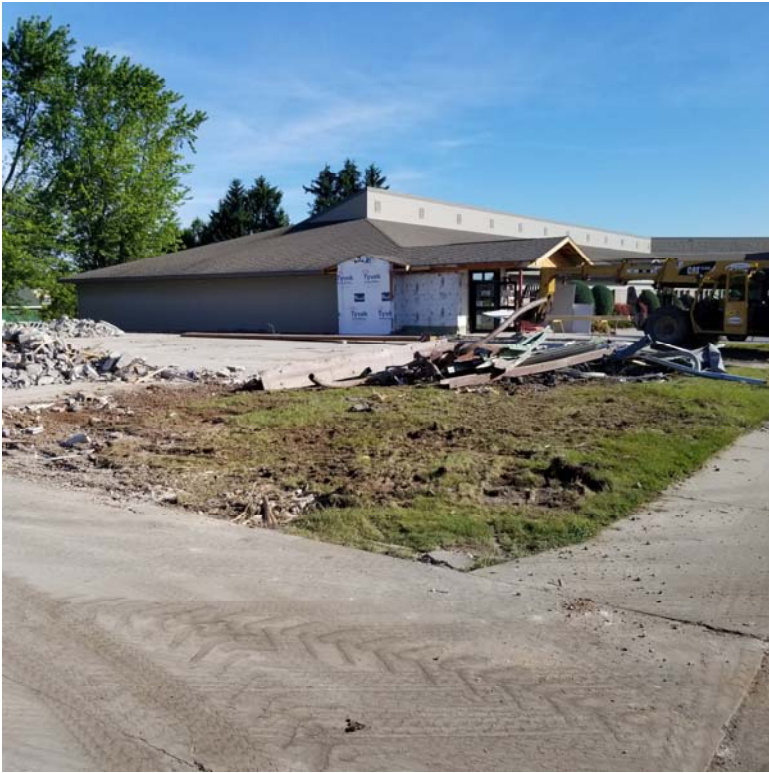
**Image #9: Steel sorted for recycling**

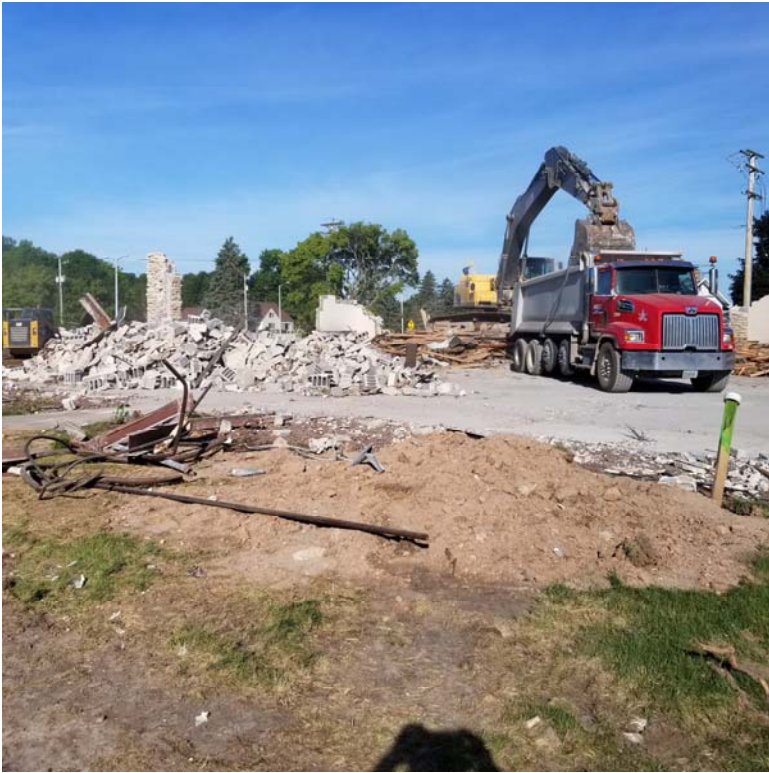
**Image #10: Debris removal- looking from the northeast**
