Project Number:

17-023

Date: 9-5-19

**Construction
Observations:**

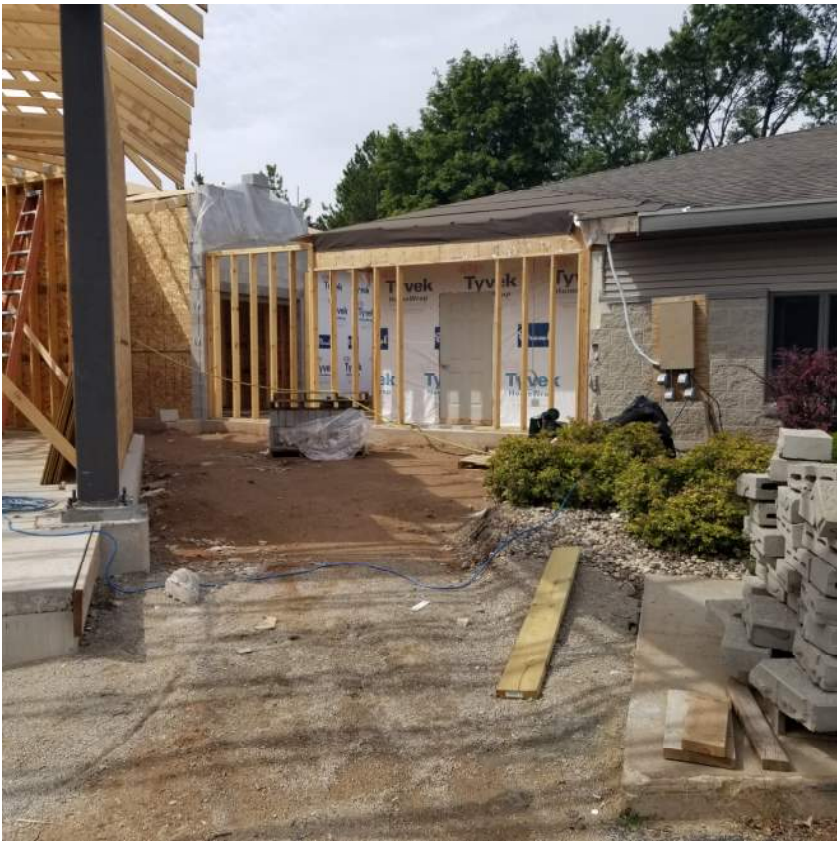
Image #1: Exterior wall @ previous building exit is now being framed in.

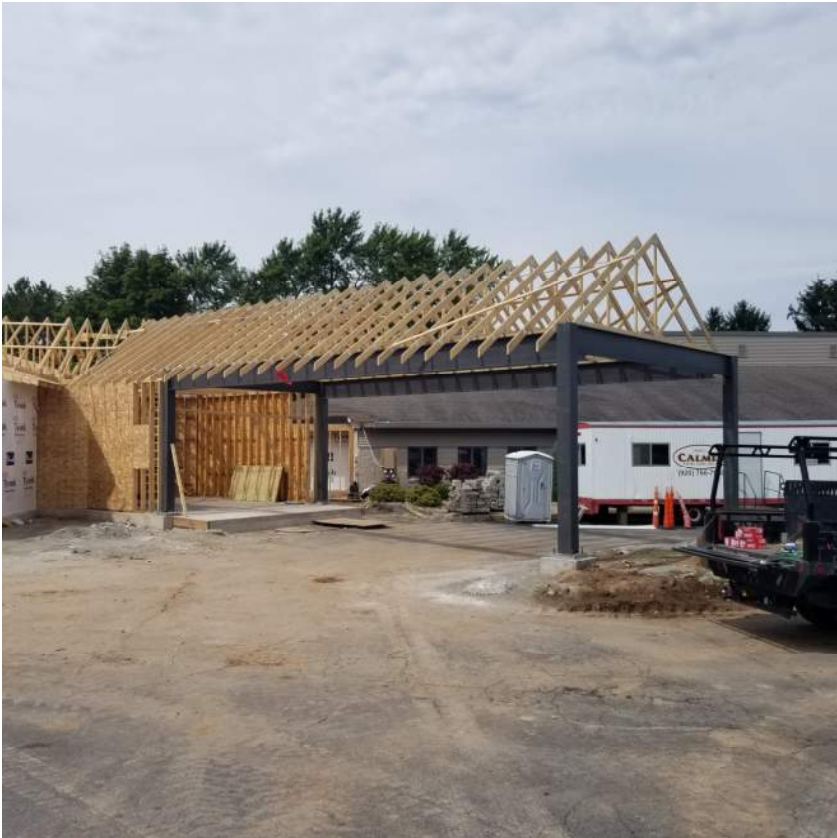
Image #2: Trusses have been set over covered drive area.

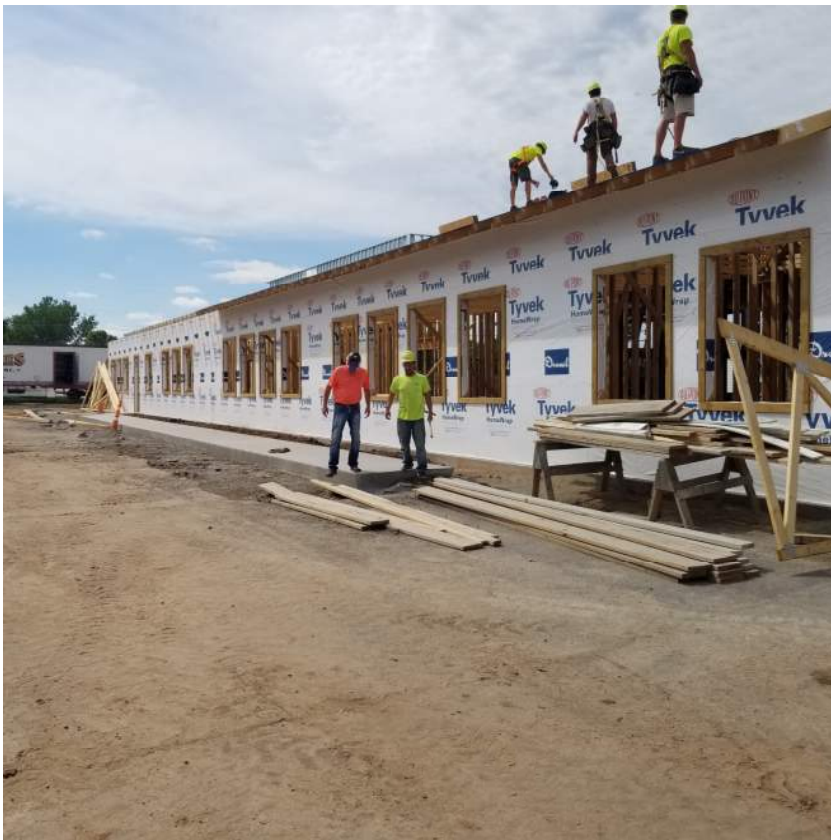
Image #3: Roof sheathing is being installed.

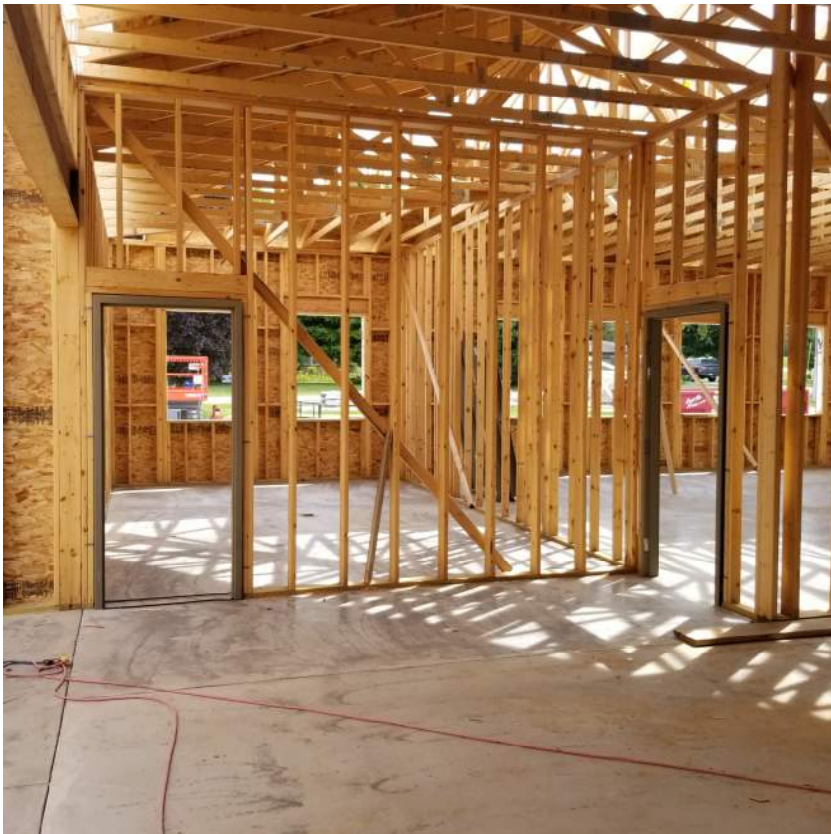
Image #4: Hollow metal frames are being set in place.

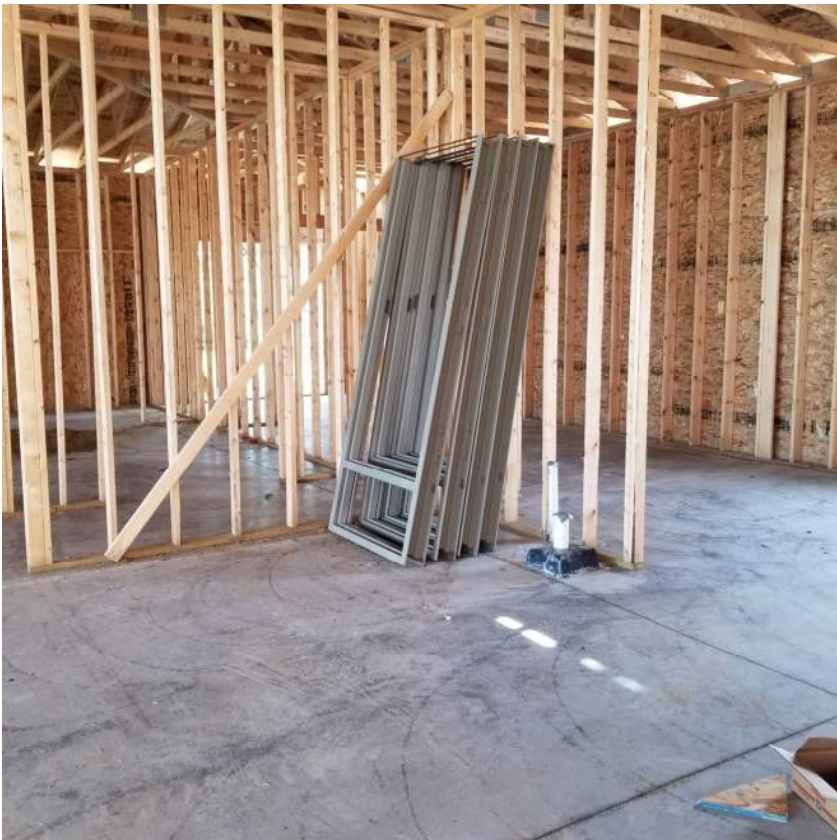
Image #5: Hollow metal frames are stored directly on concrete- they should have wood blocking under them to avoid rusting.

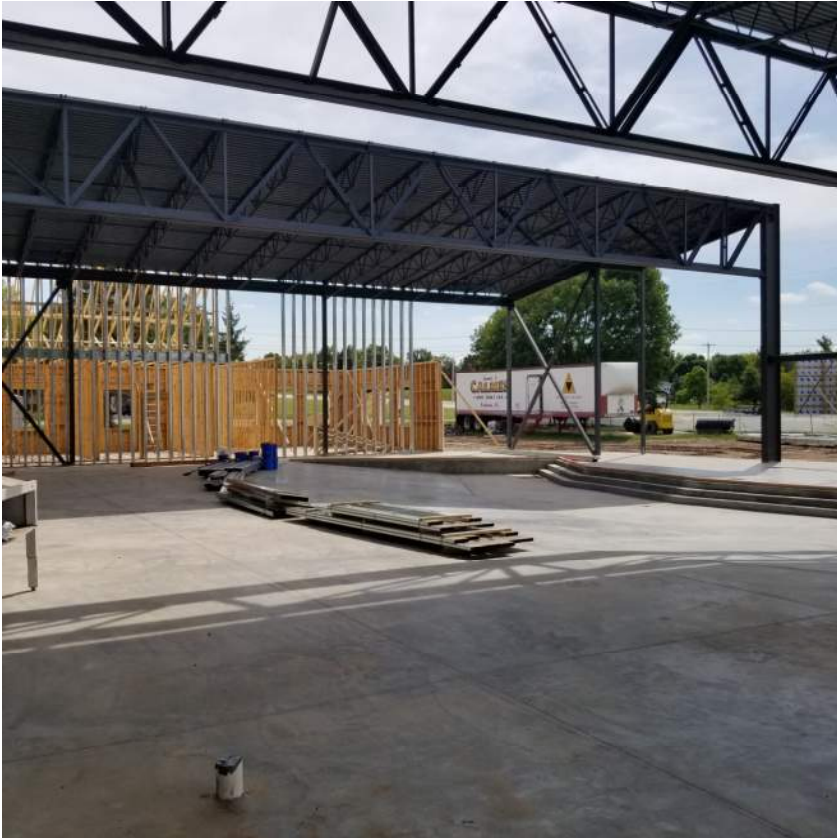
Image #6: Looking from NW to SE in sanctuary.

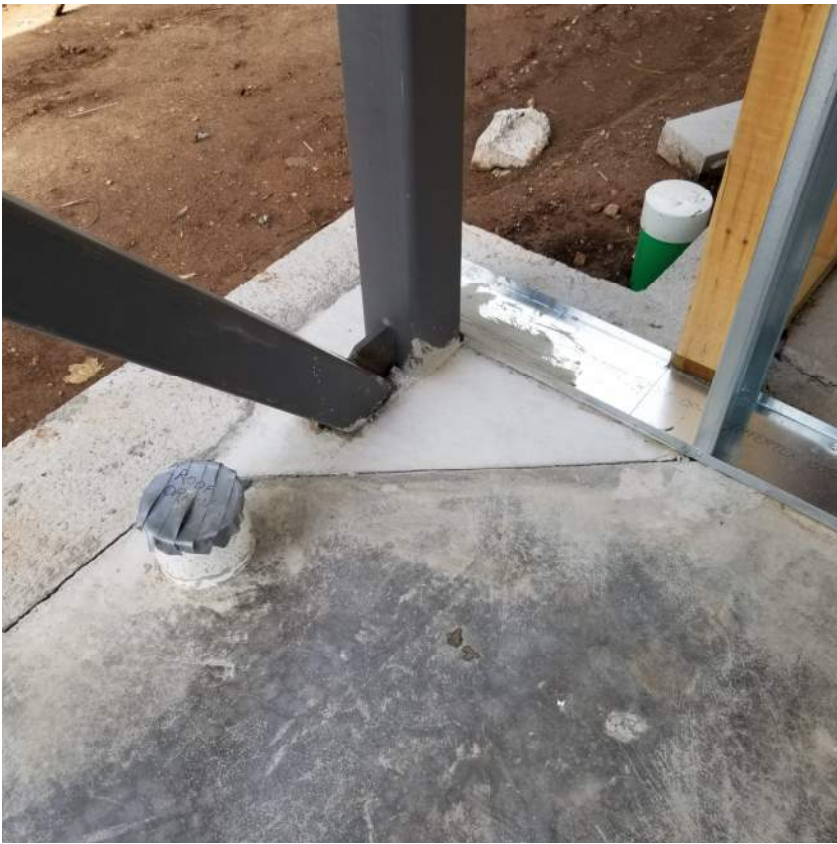
Image #7: Steel column bases have been grouted in place.

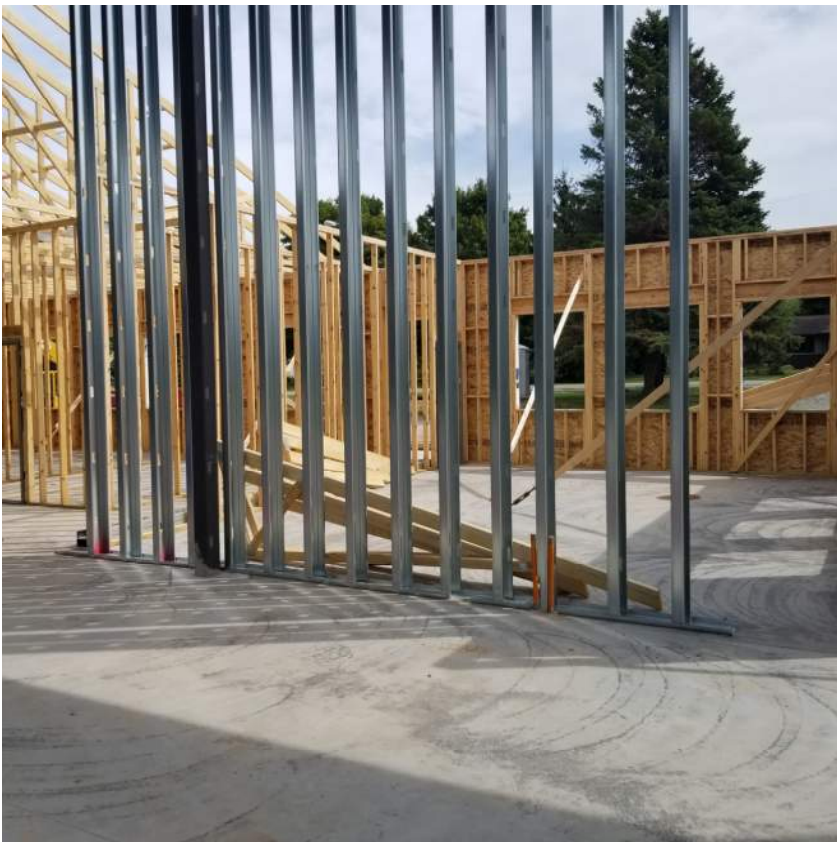
Image #8: Steel stud wall between green room and sanctuary. Need to cut a door opening in this wall per owner request.

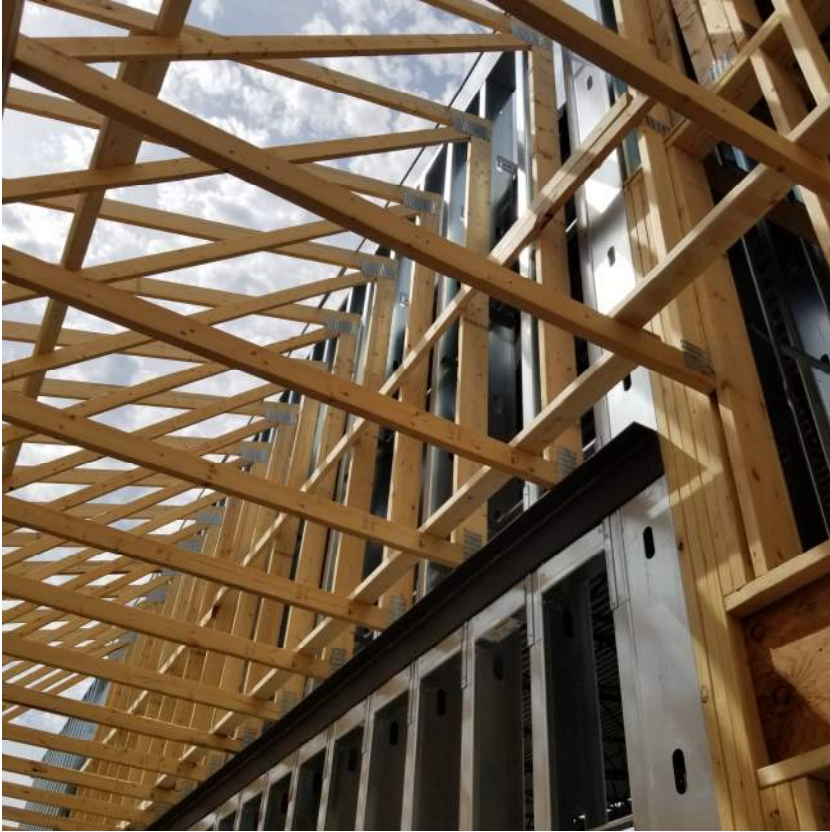
Image #9: Wood truss bearing on the east side of the church.

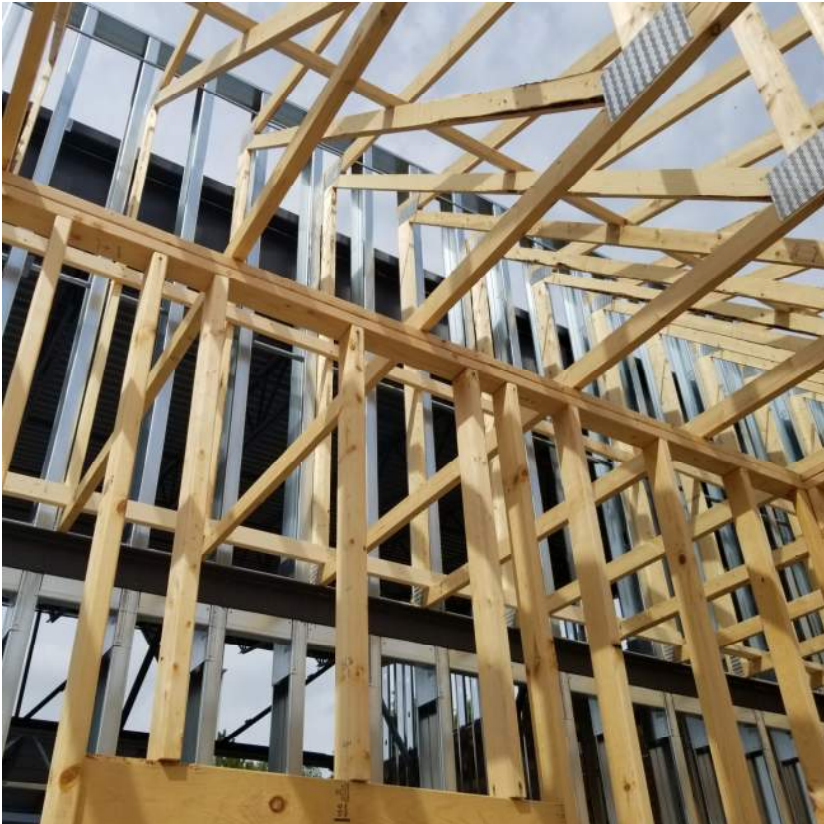
Image #10: Wood truss bearing on the east side of the church.
